West Fork Cow Creek Habitat and Fish Surveys

West Fork Cow Creek Watershed Action Plan

Partnership for the Umpqua Rivers

September 9, 2016

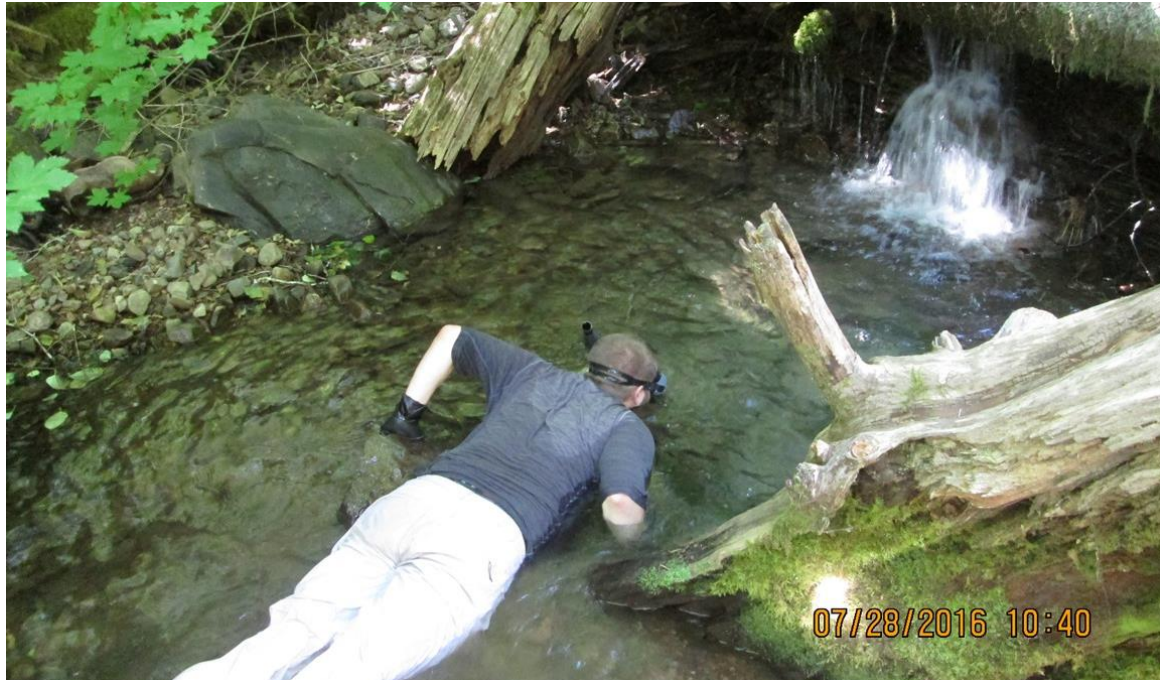
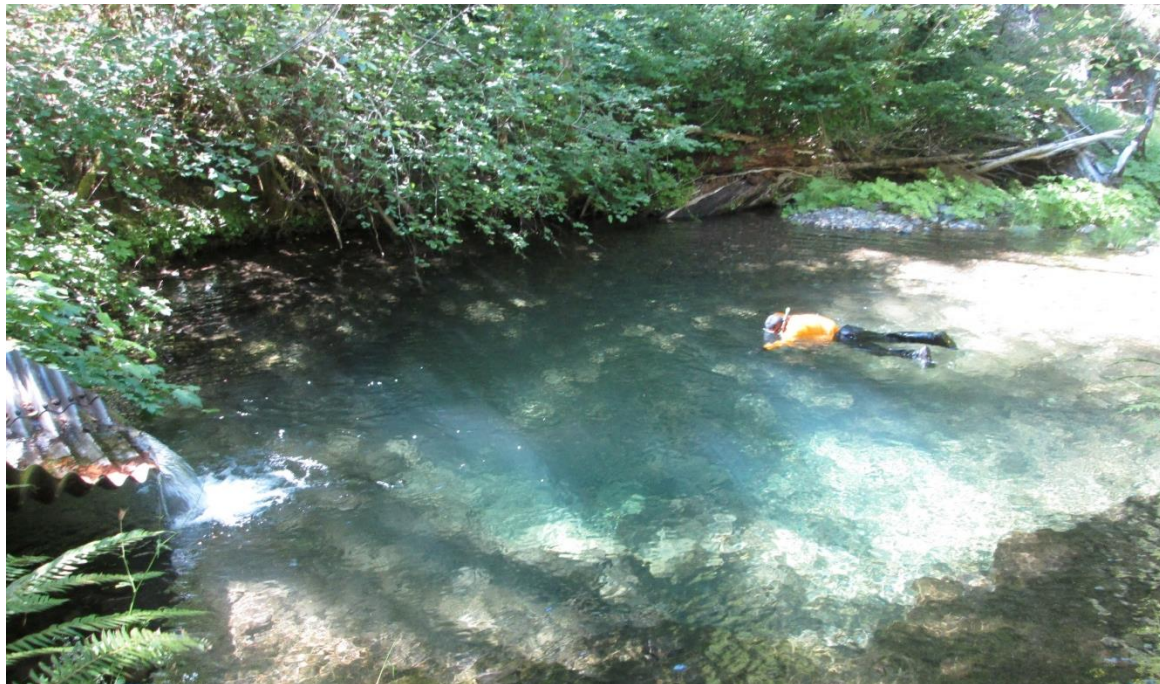
Figure 3-1. Snorkeling in a small stream (tributary to Bear Creek; above) and a larger stream that sometimes required a zig-zag pattern (West Fork Cow Creek; below).

One person snorkeled each designated reach starting at the downstream end, and a second person recorded data as described by the snorkeler. Streams were generally small enough that one snorkeler could easily see all fish while moving upstream in the middle of the channel (Figure 3-1). In larger pools (primarily in West Fork Cow Creek), the snorkeler utilized a “zig-zag” pattern to ensure all fish were observed (Figure 3-1). Fish were identified to species when possible and apportioned into two-inch categories.
